DAMAGES TO GENERAL PROPERTIES DUE TO A STORM SURGE IN JAPAN

Abstract: In cost/benefit analysis of shore protection works against storm surges in Japan, the effects of prevention from flood are computed as benefits. In this computation, flooding without the works is assumed and the reduced values of properties in the flooded area are obtained taking the loss ratios into account. The loss ratios used in Japan are based on the results of river disaster studies because little data on the damages from storm surges is available. The storm surge due to Typhoon No. 9918 that struck Japan in September, 1999 caused a storm surge in the Yatsushiro and Suo seas, and damage from flooding over wide coastal areas. The loss ratios for general properties due to storm surges from Typhoon No. 9918 were measured in Shiranui Town and Ube City.

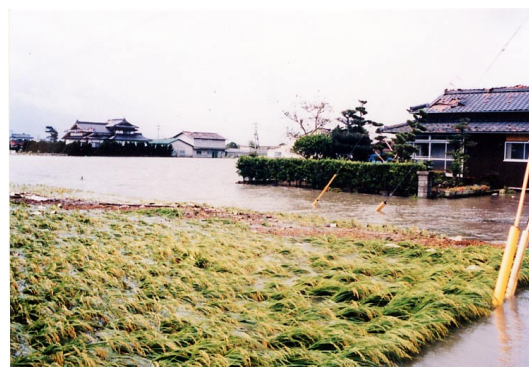
Photo 1 Flooding in Matsubase Town, south of Shiranui Town

Photos 1 to 3 show flooding and its impacts on houses in Matsubase and Shiranui towns.

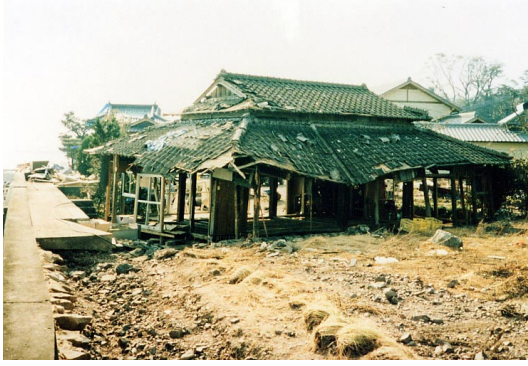
Photo 2 A destroyed house due to flood in Shiranui Town

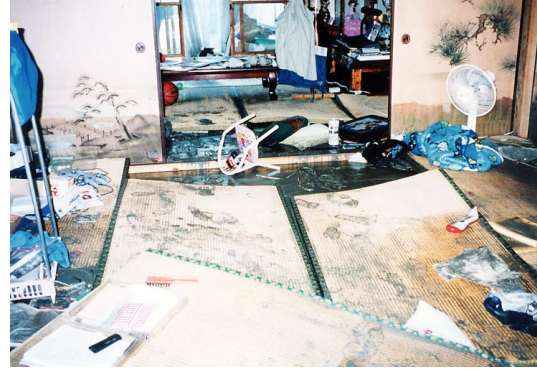
Photo 3 A room after flood in Matsubase Town
